# Texas Dependable Inspection Services, PLLC

123 Dream House Lane, Your town, TX 77881

Date of Inspection: 4/1/2024 Time: 8:00 AM

## PROPERTY INSPECTION REPORT FORM

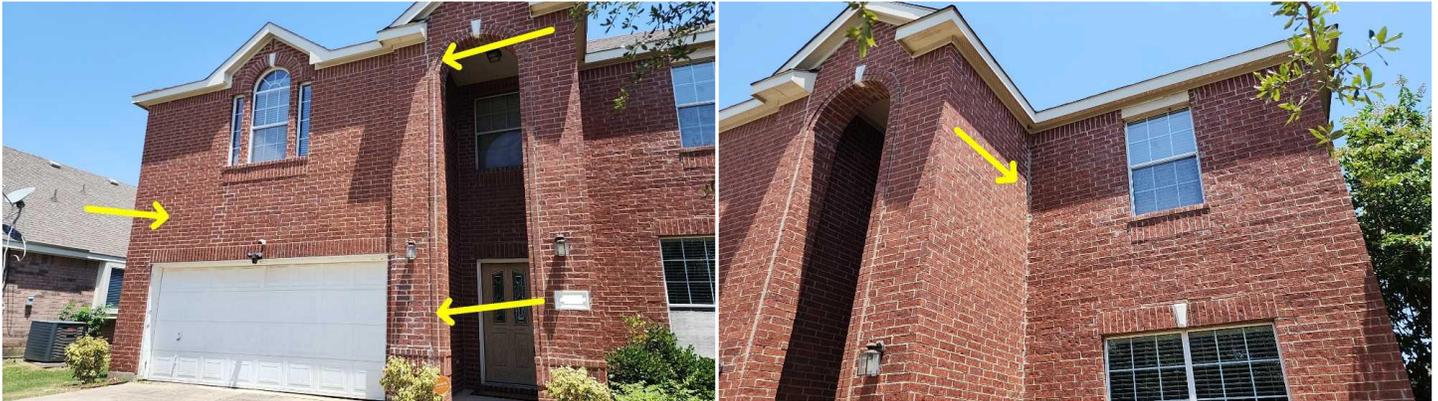
- There are minor compression cracks or missing corner(s), at one or more foundation corners. This is typically caused when the masonry siding was not properly flashed prior to masonry installation and becomes bonded to the concrete foundation. At the surface, these are considered cosmetic. Repair as necessary.

- The inspector observed indications of possible foundation or structural movement, evident mainly by (and not limited to) one or more of the following  
EXAMPLES:

Movement

AS A PRECAUTION, I recommend consulting a qualified foundation professional for repair recommendations. A structural engineer may be necessary.

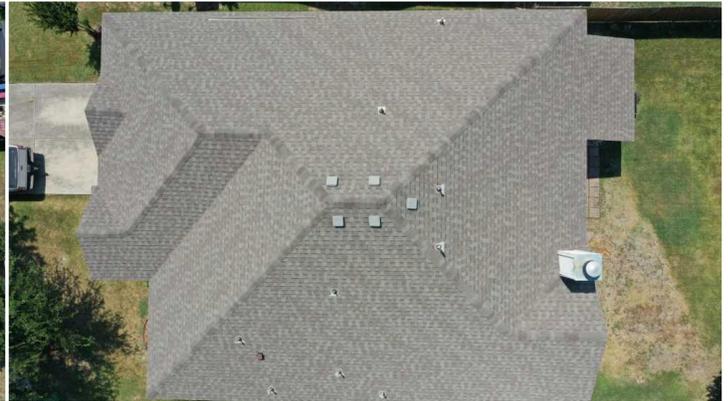
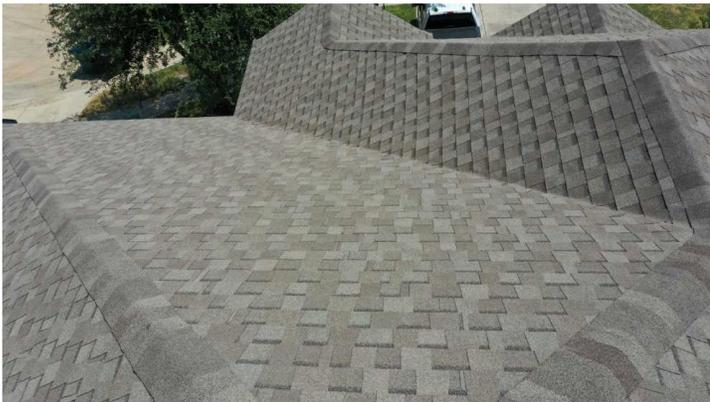
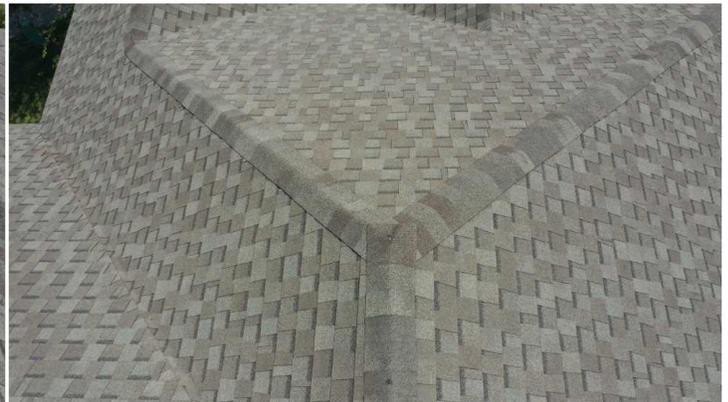
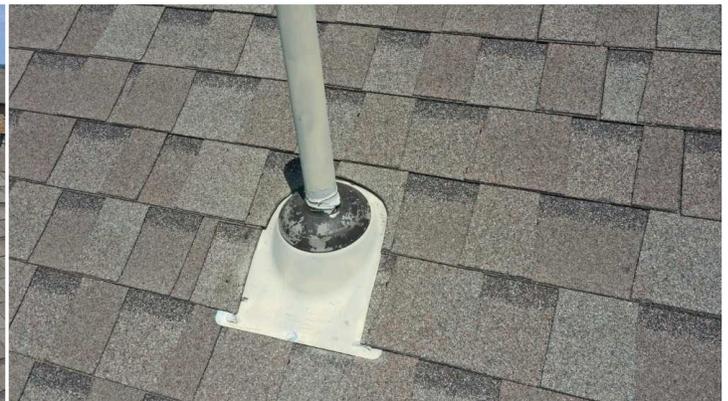
- Some shingles are damaged at various locations.
- Recommend a qualified professional roofer be consulted for these and any other necessary repairs.

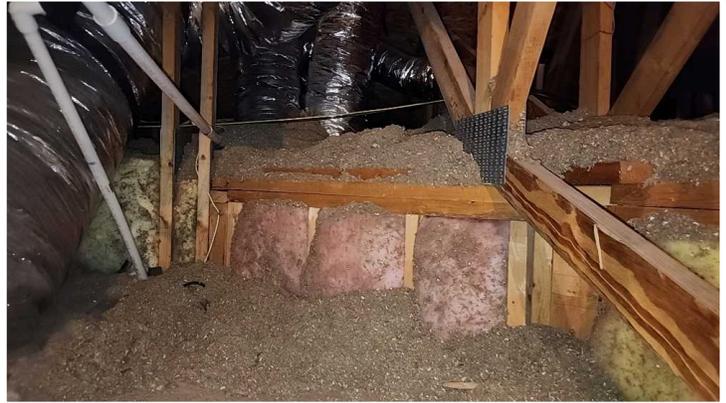
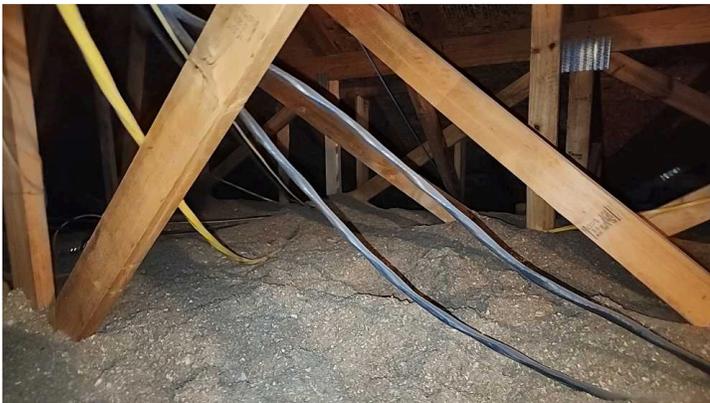
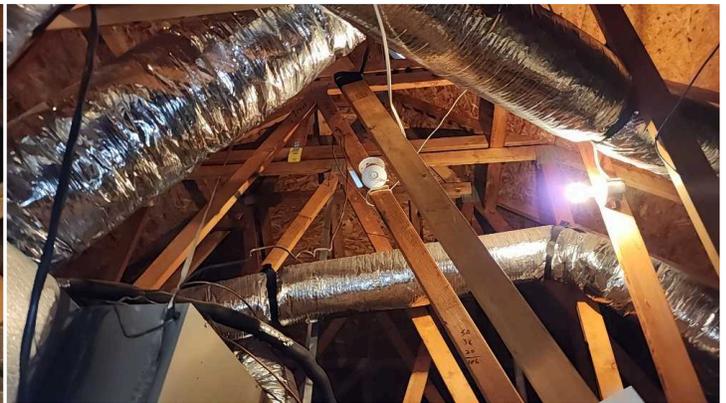
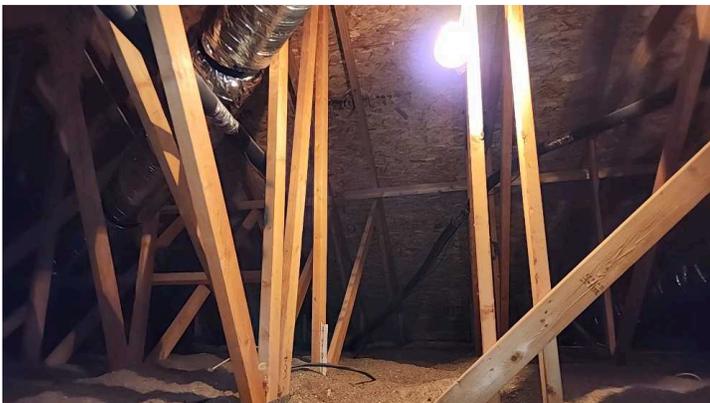
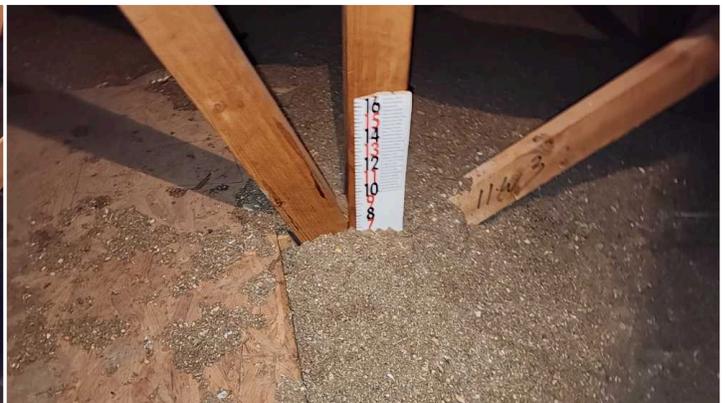
- Some soffit vents are blocked or damaged. Vents should allow for free flow of air to the attic space. A minimum of 1" (inch) gap should be maintained between the insulation and roof decking, baffles are typically used in these areas.

- Recommend additional ventilation or improving current ventilation at the attic space.
- The attic access ladder does not seal when closed.
- Recommend consulting with a licensed/qualified contractor for these and any other repairs that may be needed at this time. There are instances when a structural engineer may be needed, a licensed/qualified contractor can help make the determination.

Stains from overhead Refrigerant lines.

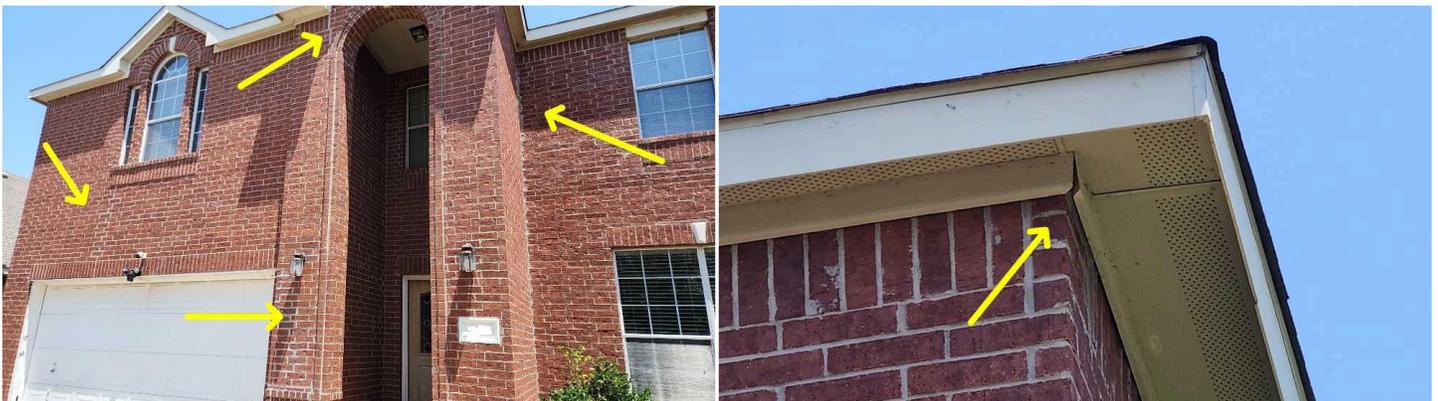
- NOTE: There are indications of previous exterior masonry repairs at one or more locations.
- Recommend trimming the vegetation so that it is not in contact with the structure. Vegetation in contact with the structure can hold moisture. A 6" to 12" air gap between the vegetation and the structure is recommended.

- There are excessive gaps along the frieze boards at the corners. These are typical indicators of potential movement at the foundation and/or exterior walls.

- The majority of the exterior siding and trim materials need routine painting or repairs.
- There are cracks at the exterior masonry walls at one or more locations. These may be indications of movement at the wall or foundation.

- There are minor interior drywall cracks at one or more locations.
- There are indications of possible wood destroying organism activity, mainly along the right exterior wall.

- Recommend consulting a qualified contractor/professional for these and any other necessary repairs.

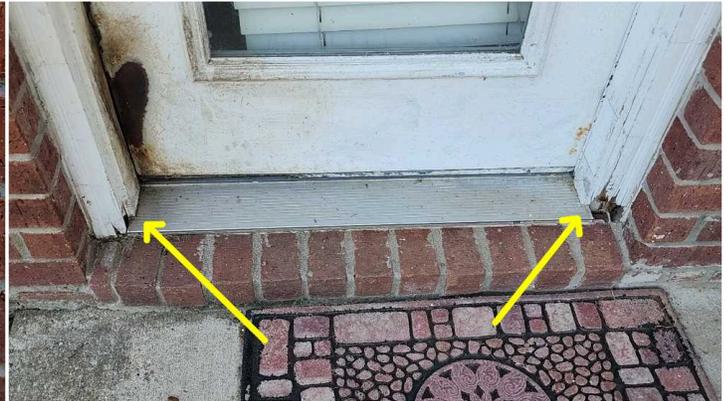
Carpenter ants

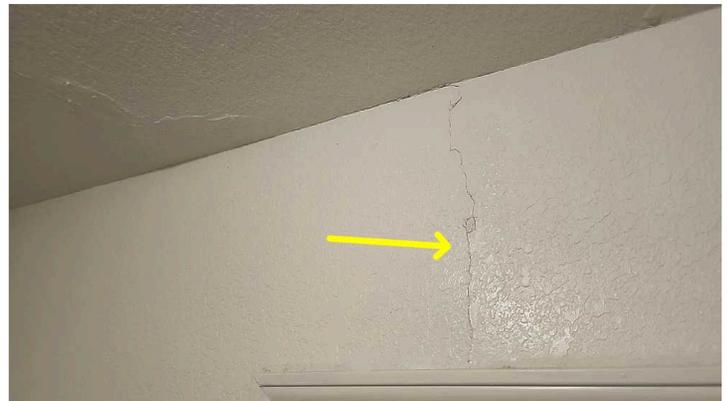
Damaged

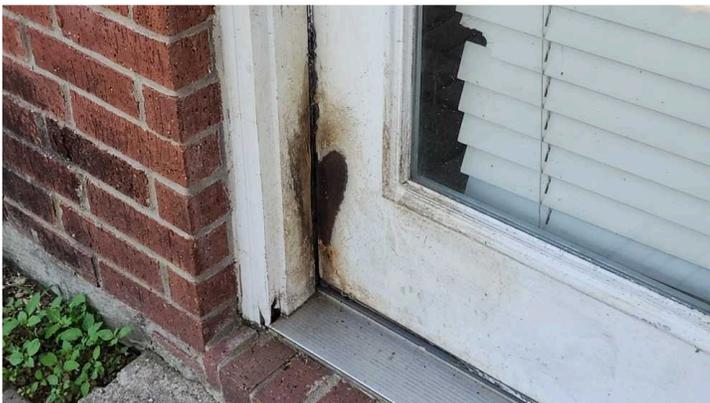
- There is deterioration or damage at one or more doors. This was observed at the back.
- The pedestrian door between the garage and living space is not equipped with a self-closing or automatic closing device.
- The front entry door is loose at the seal.

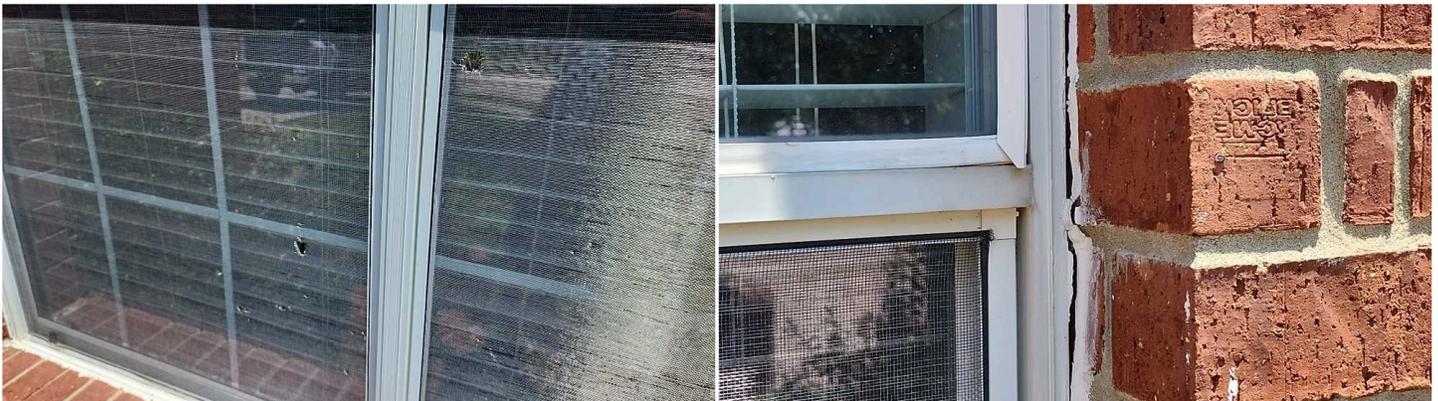
- Some of the windows are dirty or tinted causing reduced visibility. The inspector cannot confirm there is no fogging or de-laminated UV coating.
- There are torn window screens and/or damaged screen frames at one or more locations.

- Exterior caulk or approved sealant is needed between the window framing and exterior brick or siding to help prevent potential moisture penetration.
- There is damage at the exterior window spline(s) at various locations.

- Recommend that the metal window and door lintels be painted/sealed. When a lintel develops rust, the steel expands and pushes up on the masonry units of the wall. A rusting lintel can cause horizontal and step cracks in the masonry.

- Some windows did not operate smoothly. Routine maintenance is required.
- There are indications of active water penetration at the loft/bonus room, master bedroom interior window(s).

- Recommend consulting a qualified window repair/installation technician for these and any other repairs.

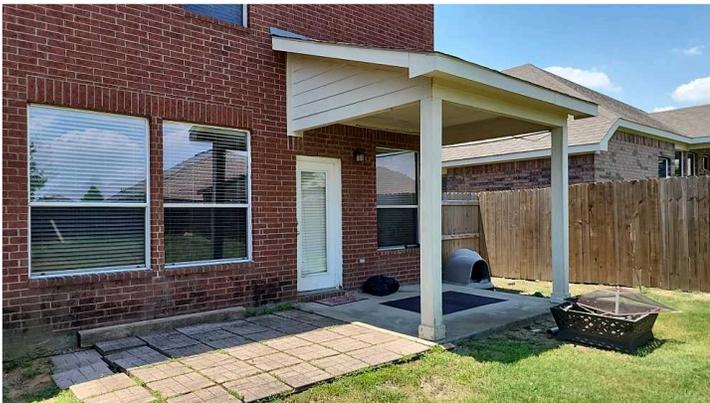
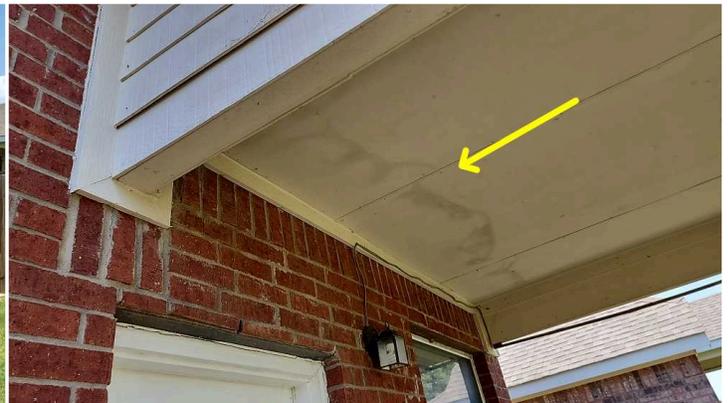
- There are indications of moisture intrusion at the porch, patio or deck cover or roofing.

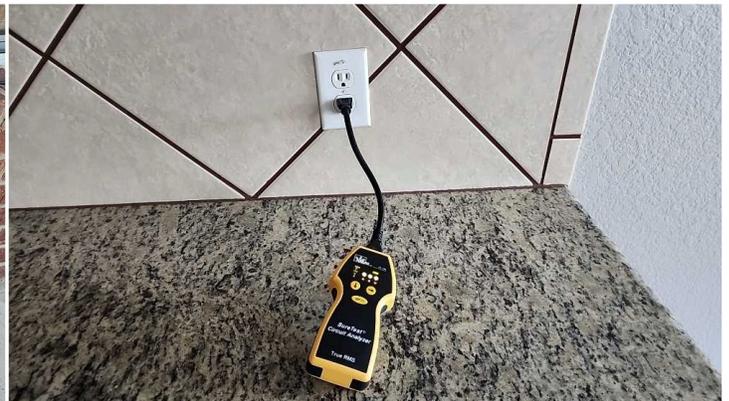
- NOTE: The home is equipped with a 4 prong dryer receptacle.
- The electrical system does not meet the current minimum standards for NEC Arc-Fault Circuit Interrupter (AFCI) breakers. The current minimum electrical standards recommend electrical receptacles with functioning AFCI protection for all receptacles that serve: kitchens, family rooms, dining rooms, living rooms, parlors, libraries, dens, bedrooms, sunrooms, recreation rooms, closets, hallways, and laundry areas. This may not have been required at the time of construction.

- Some receptacles are not (TR) Tamper Resistant type. As of February 01, 2022, all receptacles less than 5 1/2 (half) feet above the floor are required to be marked deficient if not (TR) Tamper Resistant type per the Texas Real Estate Commission (TREC) Standards Of Practice under rule 535.229.

- Recommend a weatherproof outlet cover be installed at all exterior electrical outlets.
- Recommend a licensed electrician be consulted for these and any other necessary repairs.

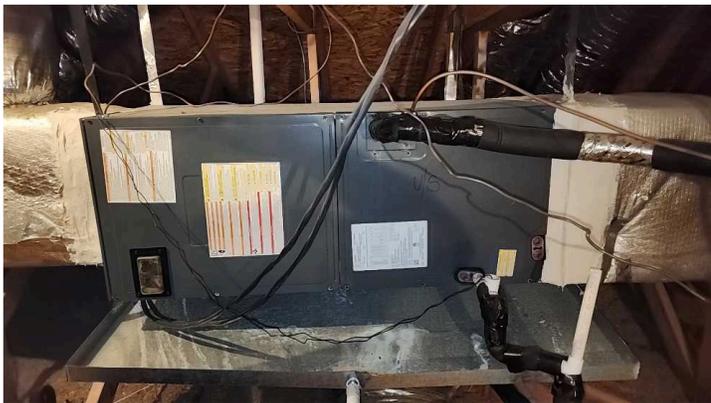
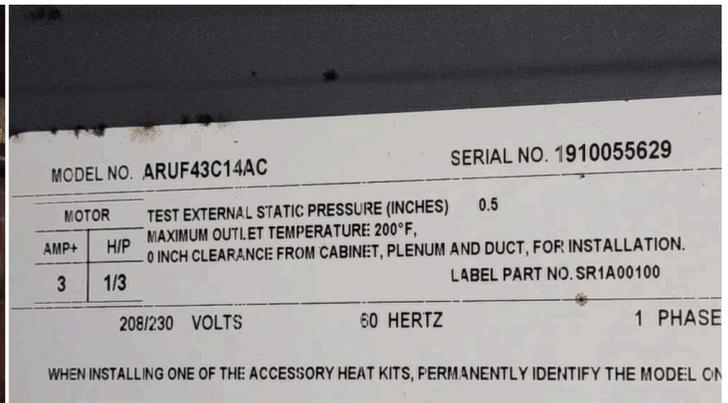
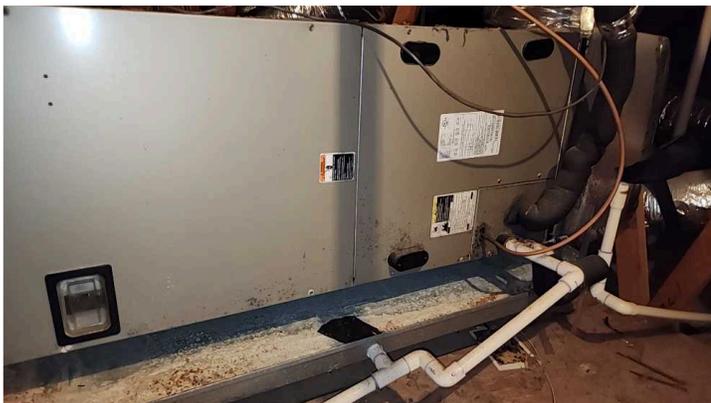
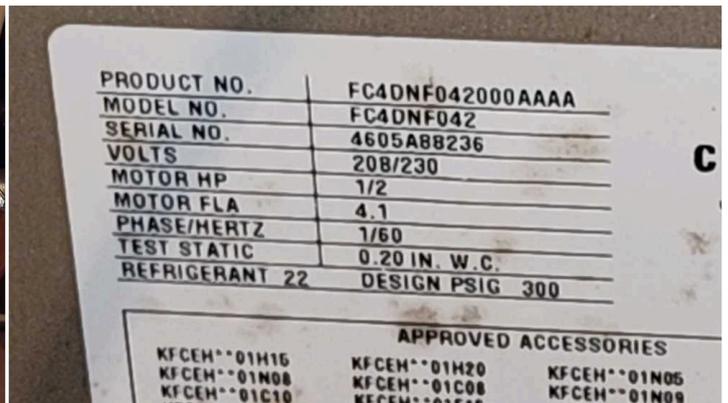
- Recommend all HVAC heating systems be serviced annually to achieve proper performance.
- The HVAC heating unit(s) is functioning as designed, the temperature differential is at least 15+ degrees f.

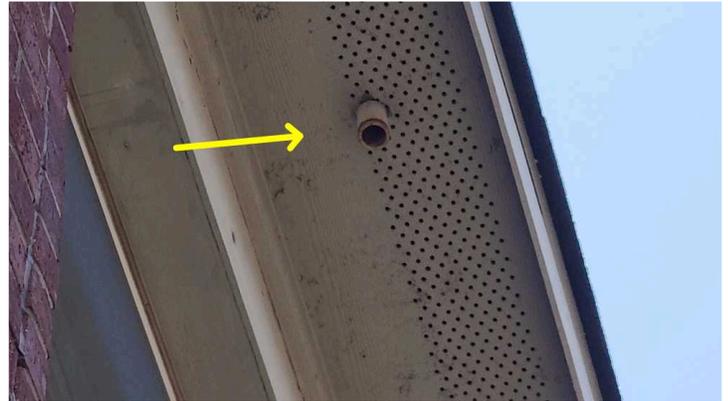
- Note: Thermostats are checked in manual mode only.
- Note: Units are not inspected for proper sizing or efficiency.
- There are indications of possible clogged A/C condensate drain line evident mainly by water or rust in the secondary condensate pan or rust stains at the exterior secondary drain line. This is typically a maintenance item, however; if not addressed promptly mechanical damage/failure can occur.

Actively discharging condensate

- Recommend consulting an A/C specialist for further evaluation/repair and to check for other repairs that may be needed at this time.

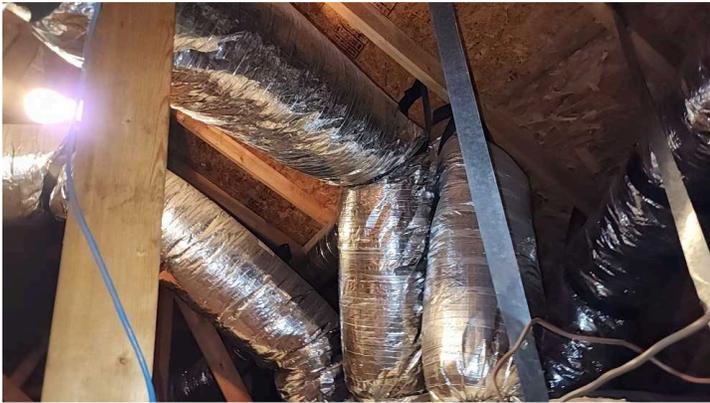
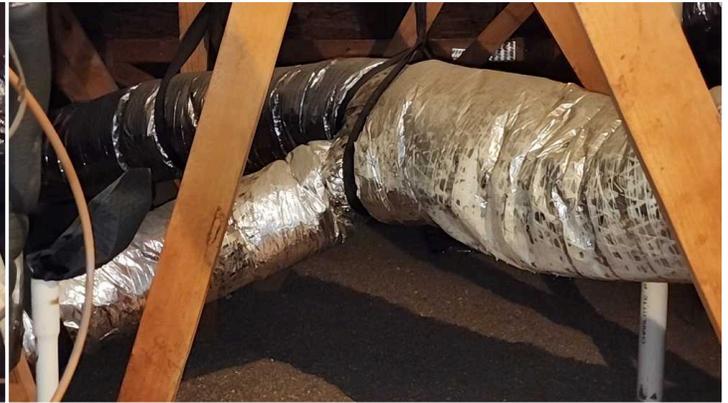
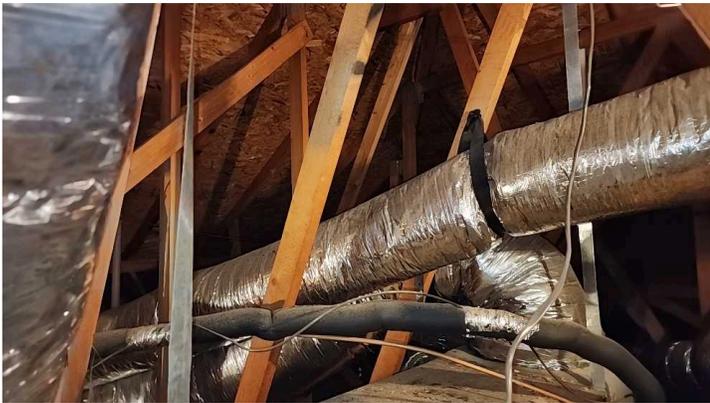
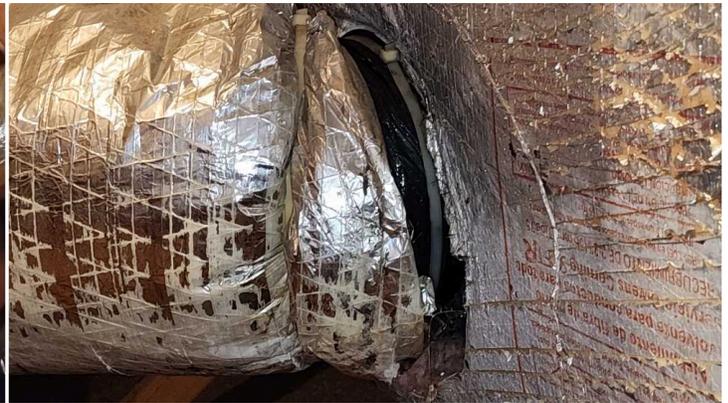
- The HVAC duct work is flex type duct work
- Some HVAC ductwork is not accessible due to limited clearances.
- The ductwork insulation is damaged or missing.

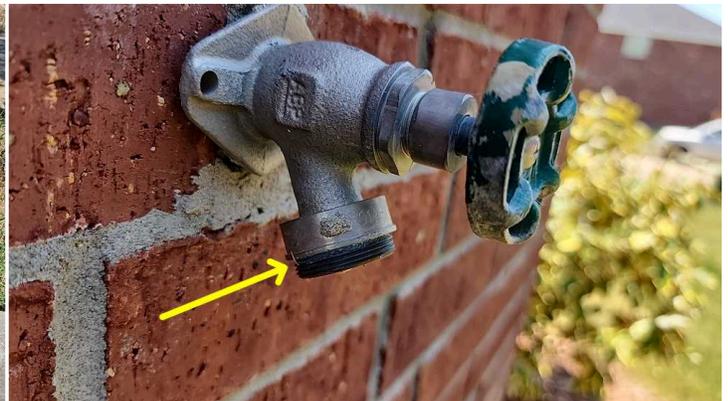
Water meter

Replace with new

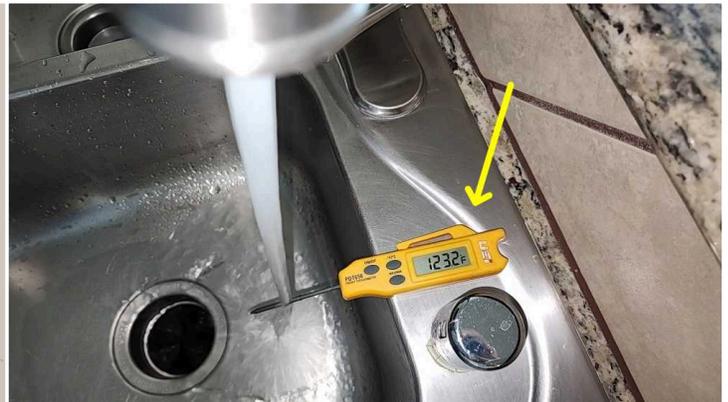
123° f

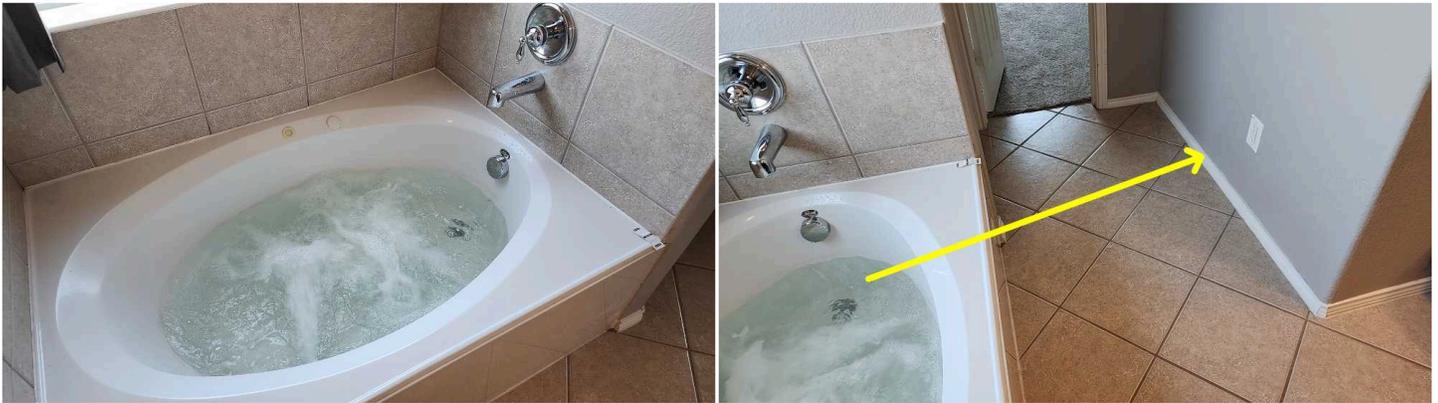
- There is no readily accessible access panel provided at the master bathroom whirlpool tub. Unable to determine the condition of the underlying materials or to determine if the water supply lines, drain lines, or tub/jets are leaking at this time.

GFCI reset

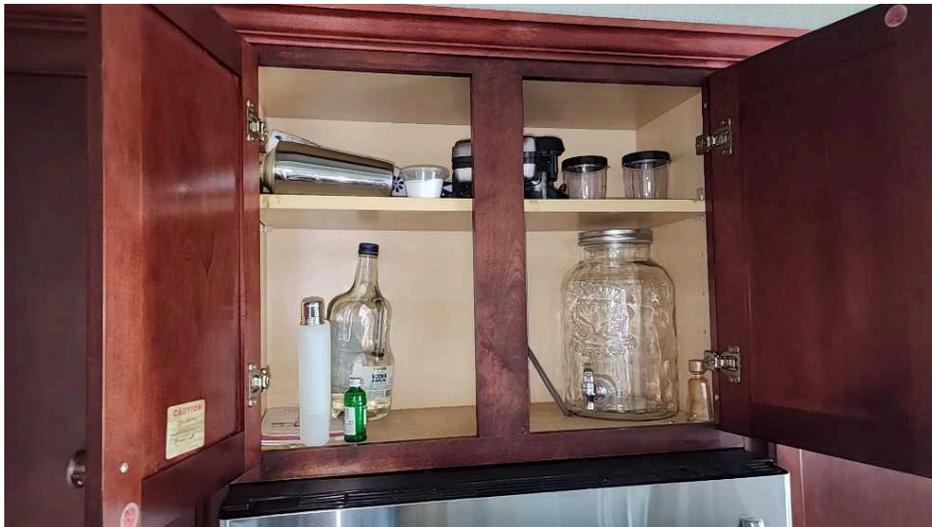
- The range hood vent configured to recirculate the air back into the kitchen. We recommend properly maintained filters according to the manufacturers recommendations.

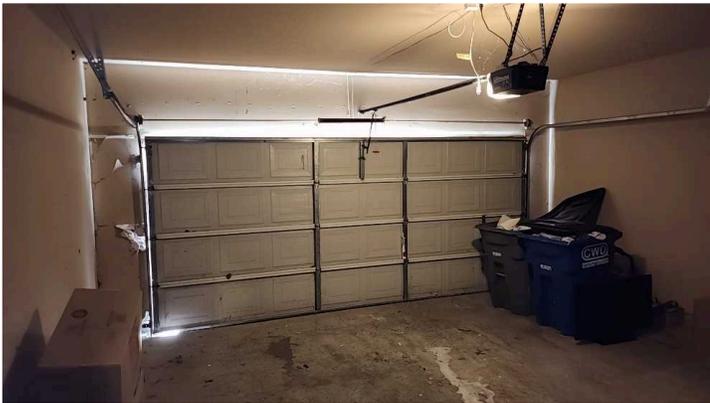
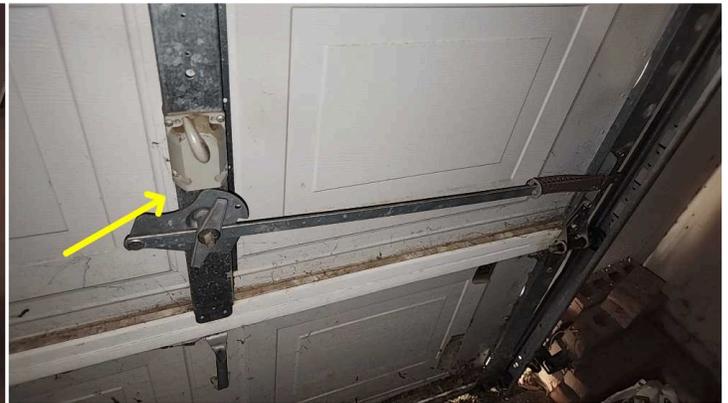
- The automatic garage door motor does not properly close as designed.
- The garage door track(s) is not properly secured or aligned.
- The garage door weather stripping is damaged.

Disabled for safety

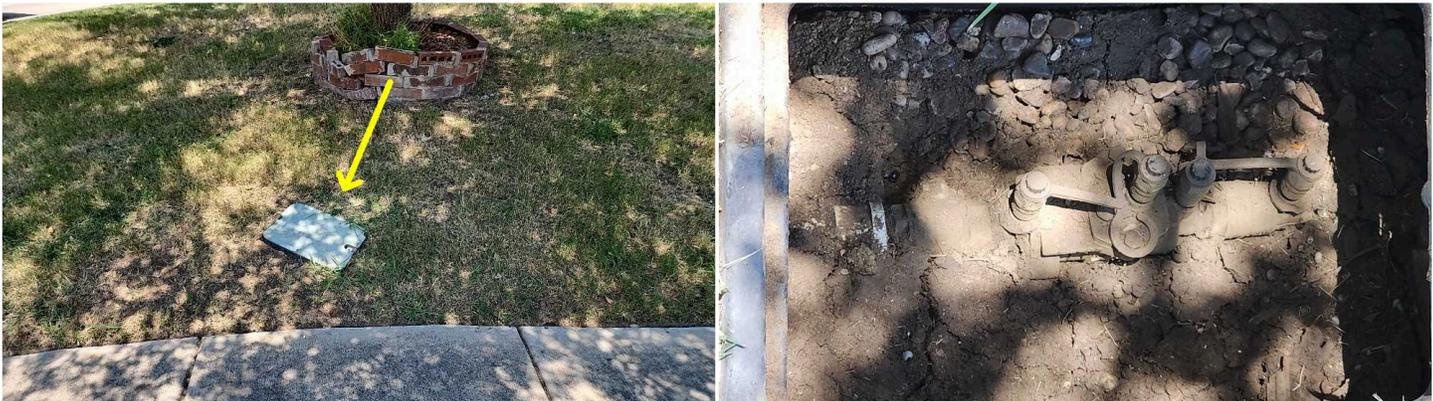
- There is no power present at the sprinkler system control box in the garage. Unable to test the system for function.
- Recommend consulting a licensed sprinkler contractor for these and any other repairs that may be necessary at this time.

Backflow preventer
